## C&DH

## 2A PRIME NCS DETECTED RT FAIL MDM FGB-2(1) - FGB

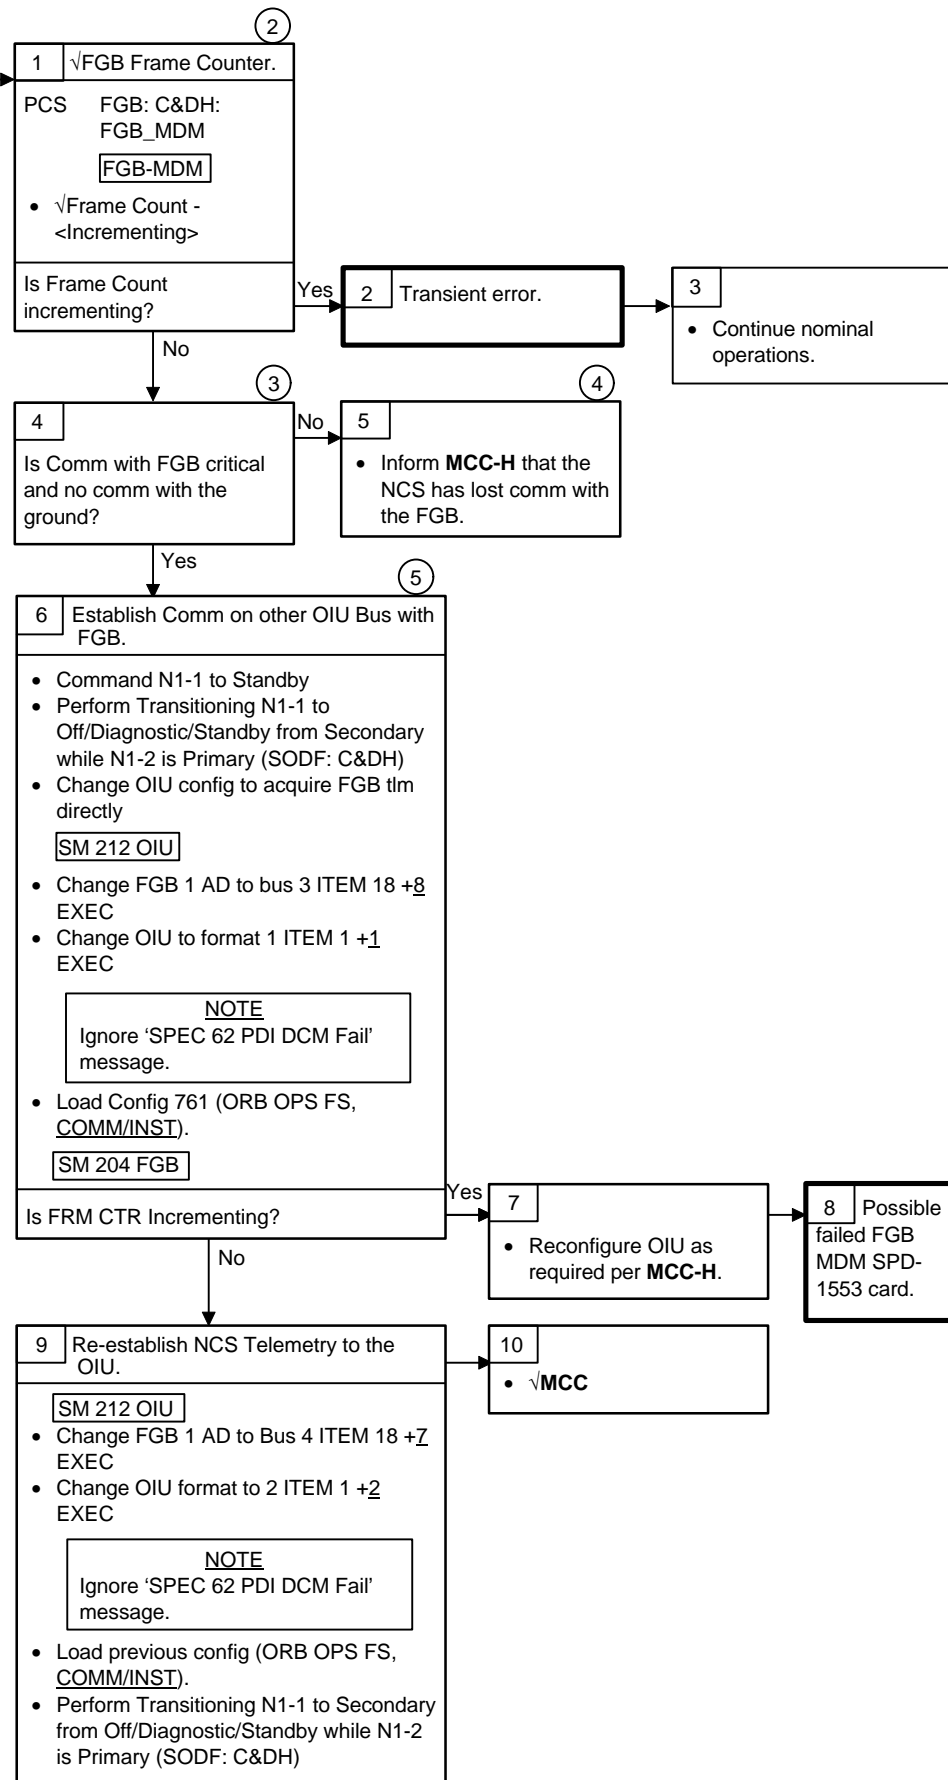
①  
Error message  
indicates that the  
FGB frame count  
has not updated.

②  
NCS software will  
search for 60  
seconds until comm  
is established with  
either FGB.

③  
Comm is critical if  
FGB commands or  
telemetry is required  
to complete a time  
critical procedure.

④  
**MCC-M** may reset  
current FGB-MDM,  
or swap to other  
FGB MDM.

⑤  
This step will cause  
loss of NCS  
telemetry to the  
ground, loss of NCS  
telemetry to NCS  
SPEC, and loss of  
secondary NCS  
telemetry.
